**RICHHOODS FORD DAM  
WASHINGTON COUNTY, MISSOURI  
NO 39727**

**PHASE 1 INSPECTION REPORT  
NATIONAL DAM SAFETY INSPECTION**

SUBJECT: Richwoods Pond Dam (MO 30727)

**OVERVIEW**  
**RICHWOODS POND DAM**

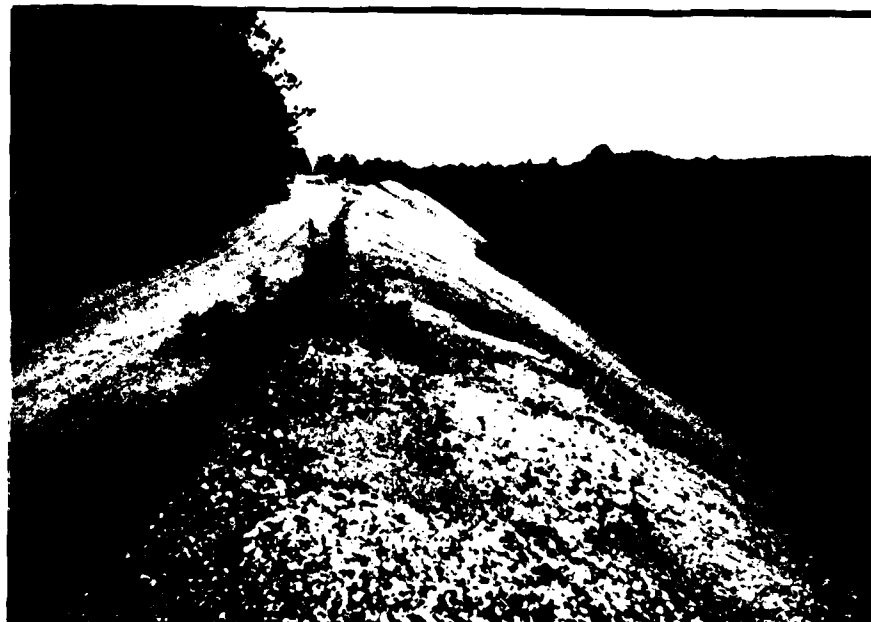
1. Roadway or crest of dam, looking northwest.
